**DATA REPORT ON
SONAR PIPELINE INSPECTION**

Indianapolis Large Diameter Pipe Video and Sonar Inspection

Project No. CS-00-085

**510028 to 510027
Little Buck Creek Interceptor**

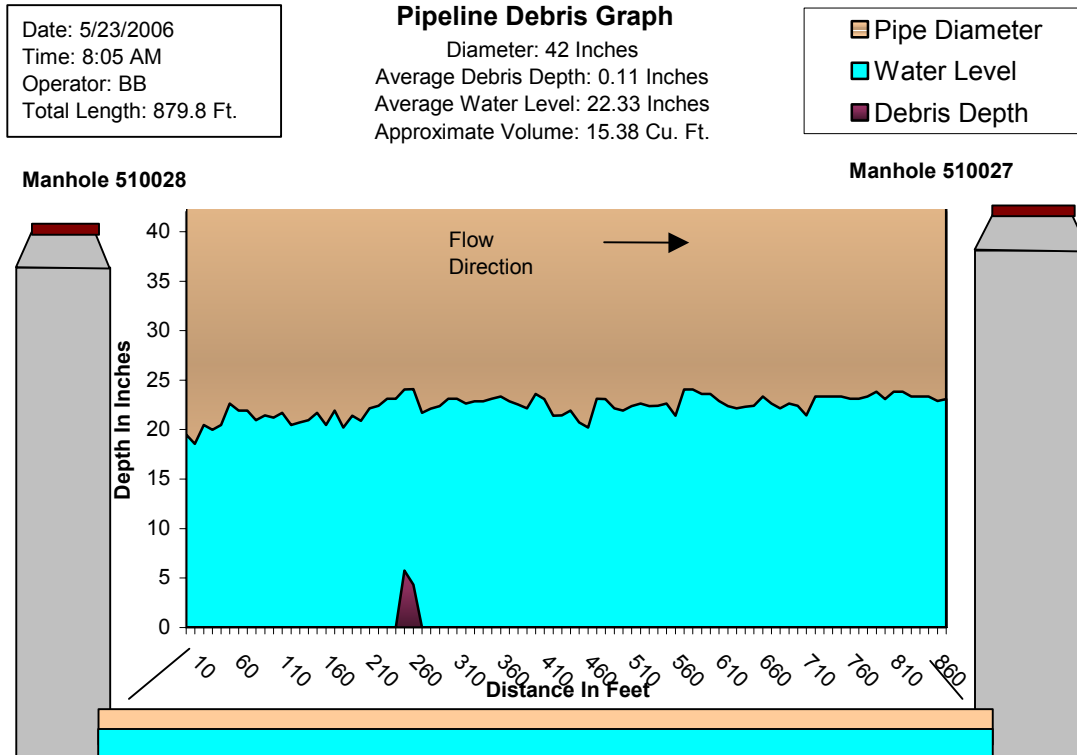
Pipeline Ovality / Deflection: The inspection shows no significant deflection. Profile with area that appear deflected represent the sonar transducer tilt within the pipeline due to elevation changes and bends within the siphon.

Sediment / Debris Volume: The data collected shown by calculation estimated slight debris in this pipe segment.

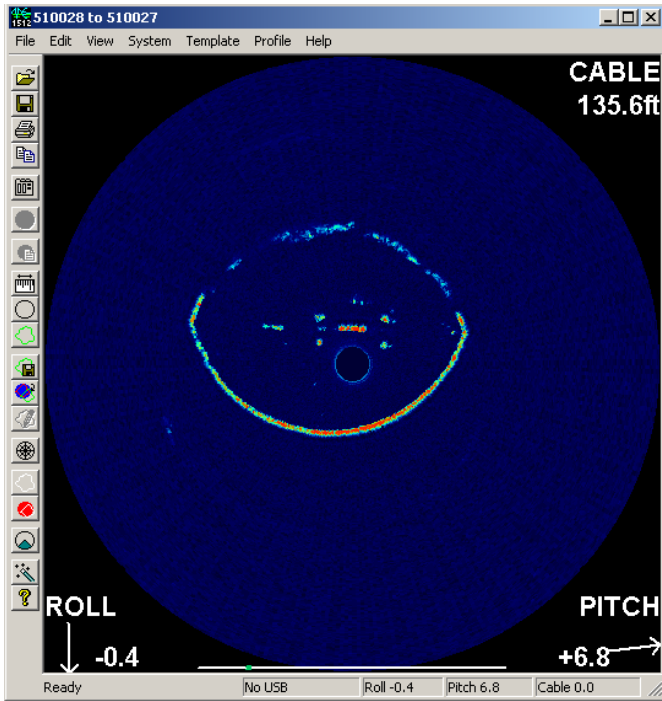
No Debris Shown

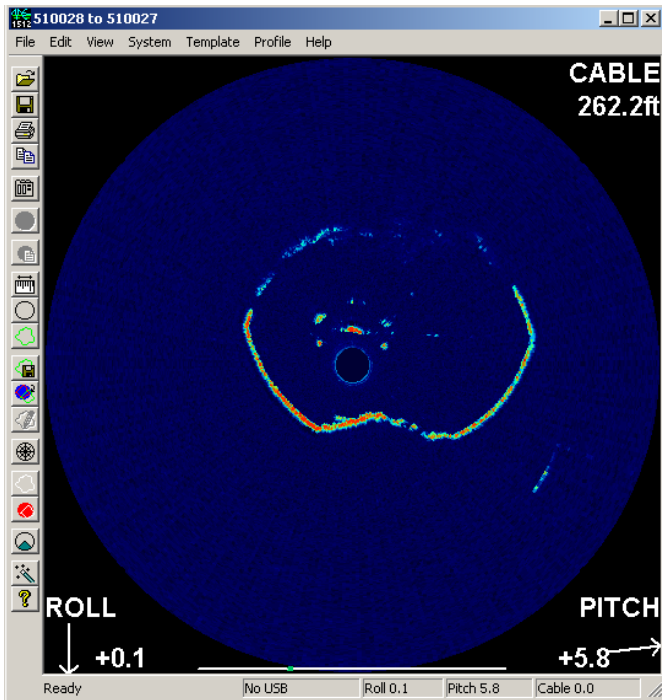
Light Debris Shown
